# Manhole Inspection Summary

Manhole # S25E\_\_039MH

Insp Date: **8/7/07 10:09 AM**

**Location** Address: **245 CAREY ST**

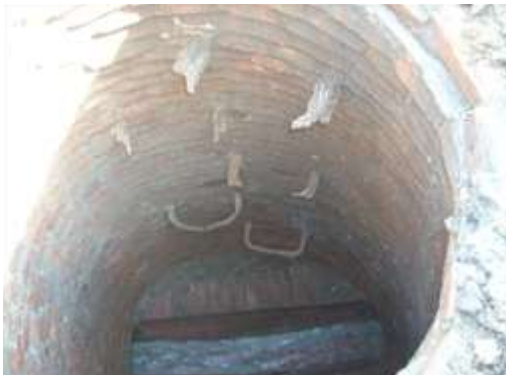
Defect 2

Count: **1** Missing: **4** ☒ **Corroded**

CORRODED AND MISSING STEPS

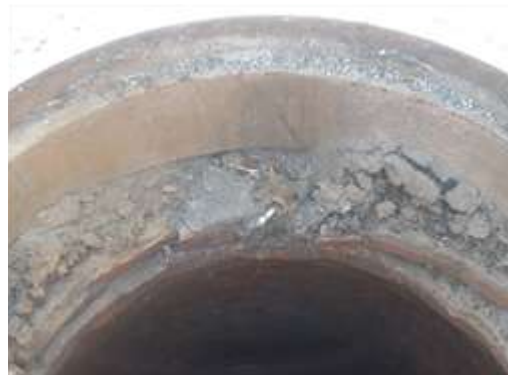
Defect 1

Offset: **3** (in.)

Condition: ☐ Sound ☐ Cracked ☐ Root Intrusion ☐ Loose Brick ☒ **Deteriorated**

FRAME OFFSET AND DETERIORATED CHIMNEY

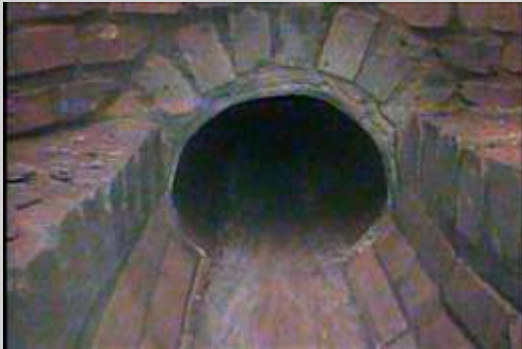
12 O'Clock Outflow

12 in. Circular Gravity Sewer  
Pipe Out @ 12 O'Clock

Pipe Height: **12** (in.) Rod and Bar (Angled)  
Pipe Material: **Clay** ☐ Pipe Lined  
Invert Depth: **9.46** (ft.) Flow Characteristics: **Fast**  
Deposits: ☒ None ☐ Mud ☐ Sludge ☐ Debris ☐ Grease  
Silt Depth: (in.) Deposits Extent:  
Infiltration: **None** Pipe Seal Cond: **Sound**

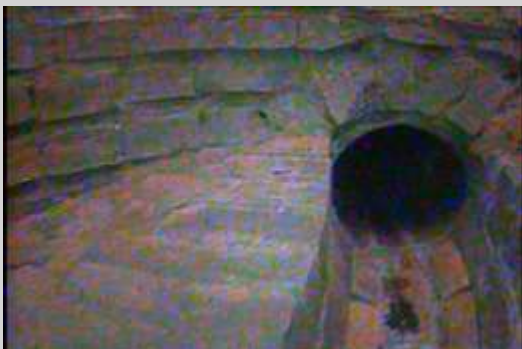
3 O'Clock Inflow

8 in. Circular Gravity Sewer  
Pipe In @ 3 O'Clock

Pipe Height: **7.2** (in.) Rod and Bar (Angled)  
Pipe Material: **Clay** ☐ Pipe Lined  
Invert Depth: **8.63** (ft.) Flow Characteristics: **Slow**  
Deposits: ☒ None ☐ Mud ☐ Sludge ☐ Debris ☐ Grease  
Silt Depth: (in.) Deposits Extent:  
Infiltration: **None** Pipe Seal Cond: **Sound**

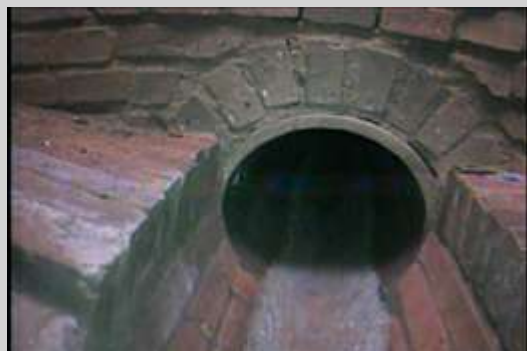
6 O'Clock Inflow

12 in. Circular Gravity Sewer  
Pipe In @ 6 O'Clock

Invert Depth: **9.52** (ft.) Flow Characteristics: **Fast**

Infiltration: **None** Pipe Seal Cond: **Sound**
